El Portal Fire – Sediment/Debris Runoff Mitigation

Scoping Trip Report

September 25, 2014

Yamabe & Horn Engineering, Inc.

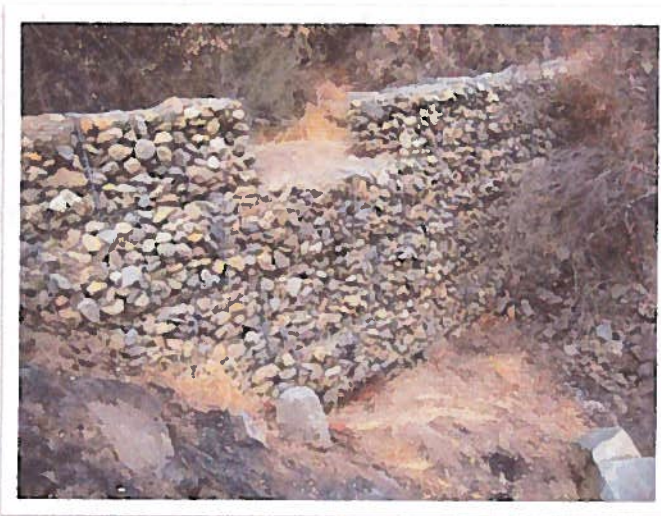
Our site visit included a cursory inspection of the existing gabion weir located approximately 480' west northwest of the Foresta structure. The existing weir is located within the drainage channel. It consists of stacked gabion wire baskets filled with rounded stones with approximate diameters ranging from 2-inches to 8-inches. The weir appeared to have 5 lifts with each lift being about 3-feet tall. The thickness of the structure is approximately 6-feet wide, and the top lift is only 3-feet wide and situated flush

with the downstream edge. The weir spillway was measured to be 10-feet above the flow-line of the drainage channel on the downstream side. The top of the gabion structure was measured to be 13-feet above the channel bottom on the downstream side. On the upstream side, the weir overflow was measured to be 4-feet above the drainage channel. It appears that over time, approximately 6-feet of sediment has been accumulated on the upstream side of the gabion structure.

Based on rough volume calculations, the existing gabion weir could retain approximately 70 cubic yards of material if it remains at the 4-foot depth. If the existing sediment is removed and the upstream height of the weir approaches 10-feet, our volume calculations yield a volume of 170 cubic yards. These calculations are based on the existing width of the gabion structure at 42-feet and a longitudinal retention of 60-feet upstream.

As recommended in the Geologic Hazard Assessment Report and Hydrology Resource Report, the existing sediment deposited on the upstream side of the weir could be removed to increase the volume capacity of the structure.

Increasing the sediment detention volume by increasing the height of the existing weir would require design from a geotechnical engineer and structural engineer. The integrity of the existing structure would need to be assessed and determined to be capable to withstand increased loads.

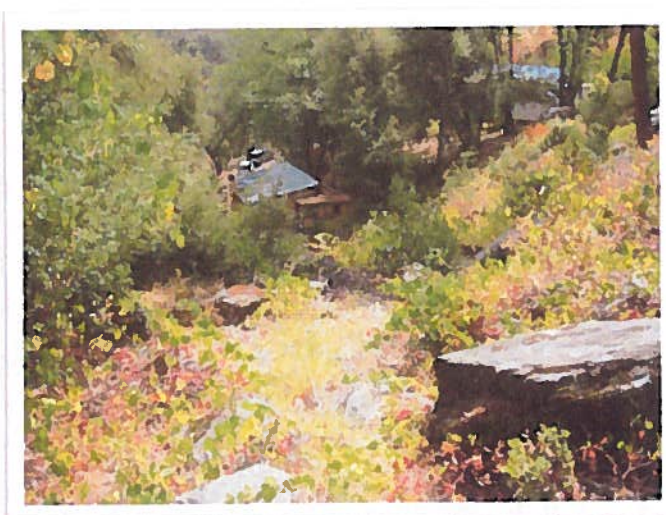
As discussed previously, this drainage channel rises approximately 280-feet in elevation within the first 1000-feet above the structure. The terrain immediately upstream of the structure is rocky and overgrown with ground cover including poison oak. The channel does not noticeably flatten out as it rises upstream. The side slopes of the channel range from approximately 20° to 45°. The slopes of the channel appear to consist mainly of igneous rock with very little exposed sediment. Construction access to the channel will be limited to walking or by helicopter.

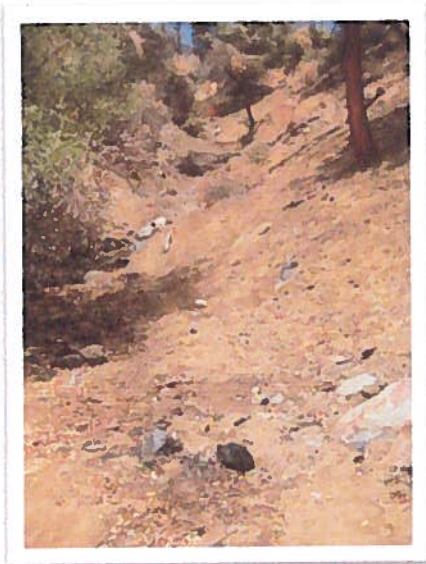
As discussed previously, this drainage channel rises approximately 440-feet in elevation within the first 1000-feet above the structure. The terrain immediately upstream of the structure includes rocks with diameters ranging from 3-inches to 2-feet, exposed soil and vegetation. The channel does not noticeably flatten out as it rises upstream. The side slopes of the channel range from approximately 20° to 45°. Construction access to the channel will be limited to small construction equipment around the house structure or along the dirt road upstream.
